## Portico farmhouses of the Vistula Delta: architecture, current state and finite element modelling of timber roof truss under material and cross-section uncertainty

**Abstract:** The article focuses on the oldest surviving I-type portico houses located in the Vistula Delta, which were built in the 17th and 18th centuries. The study describes the houses' origins, structure, details of roof structures and technical condition, and it also includes numerical modelling of a roof truss and its mechanical analysis. Numerical models of the roof trusses are defined and analysed by means of the finite element method. Global sensitivity analysis with the use of the polynomial chaos expansion method is used to study the influence of uncertainties in material properties of wood, such as Young's modulus and the friction coefficient, and also the beam cross-sectional height in the output of the numerical model of the structure. The outcomes show that uncertainty of beam height exerts the dominating influence on the maximum deflection of the roof truss hence accurate measurements of geometry are of great importance in the planning of conservation and renovation of such historic structures.

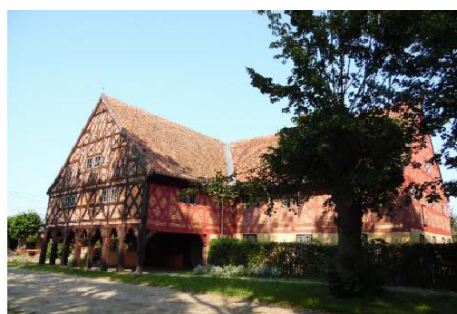
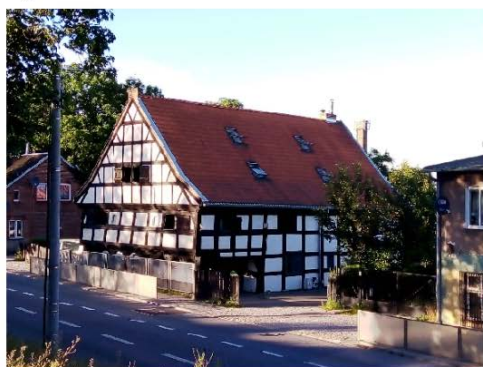
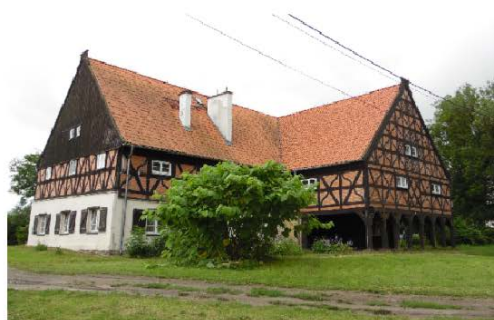
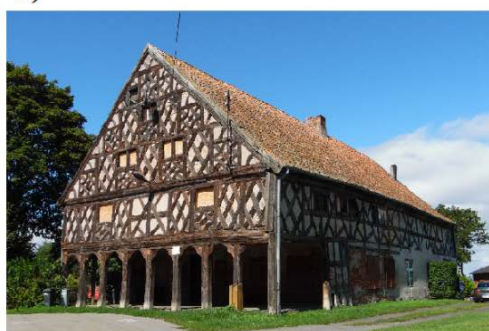
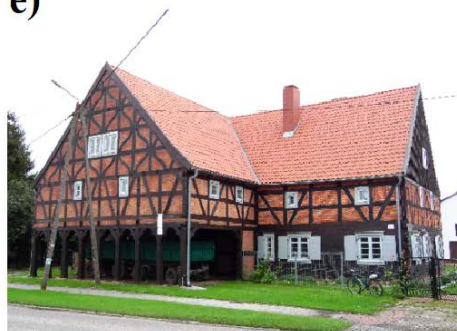
Figure 1. Three types of houses; a) 1, 2 – “I-type” house, 3; The portico houses in: b) Gdańsk Lipce c) Klecie d) Trutnowy e) Miłocin f) Nowa Kościelnica

Kloeppel (1924) differentiated three basic types of houses, (Figure 1a). It should be noted that the term *portico* should be treated somewhat conventionally here, and in some cases, the term *arcade* might be substantiated. In the building of the first and second type, the portico constituted the facade of the house, so we can call them I-type houses. The second type was in fact a result of the development of the I-type plan by adding a wing to the body of the house. Therefore, for this study they can also be classified as

The oldest preserved house in Lipce by Gdańsk (Germ. Guteherberge) was built ca 1600 (Kloepfel 1924 ; Bertram, Kloepfel, and La Baume 1924), (Figure 1b). The newest houses, retaining traditional style and proportions, come from the 1840 (Woede 1980).

by Gdańsk (Germ. Guteherberge) (Figure 1b), Klecie (Germ. Klettendorf) (Figure 1c), Trutnowy (Germ. Trutenau) (Figure 1d), Miłocin (Germ. Herzberg) (Figure 1e), Nowa Kościelnica (Germ. Neumünsterberg) (Figure 1f).

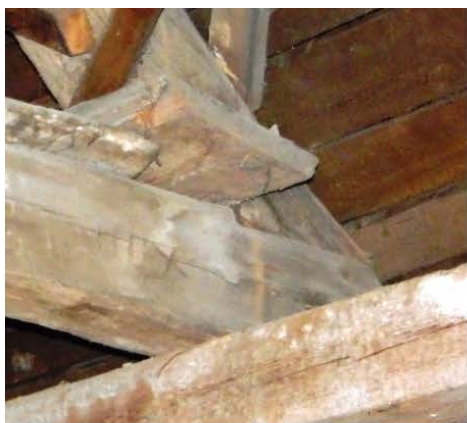
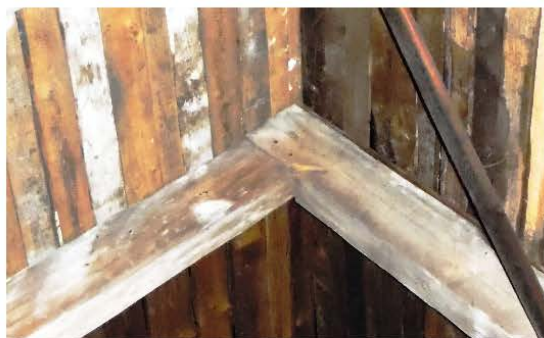
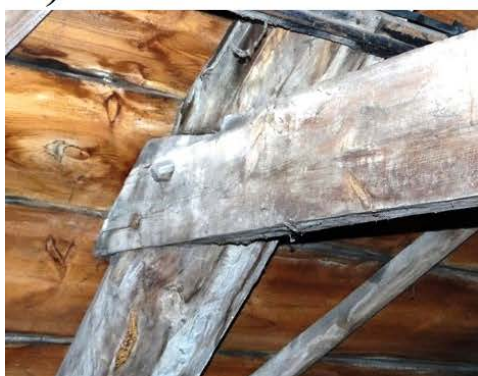
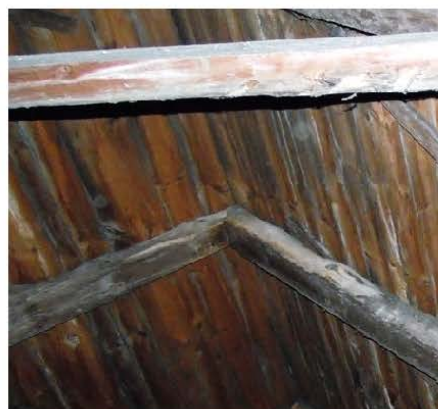
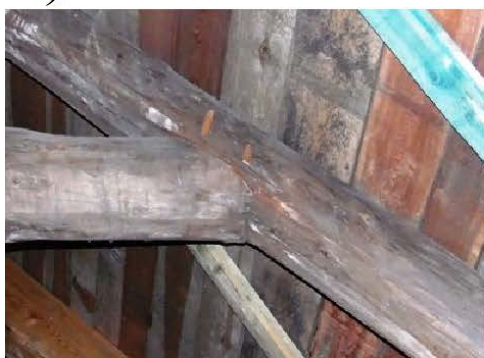
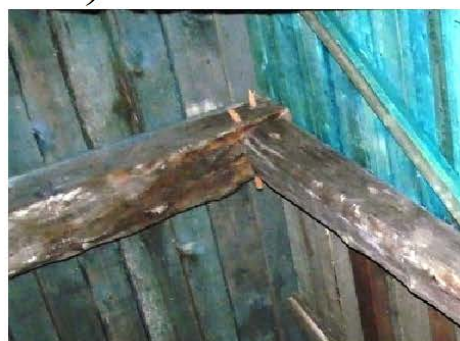
Figure 6. Traditional carpentry joints - current state: a) dovetail joint (Trutnowy) b) lap joint (Trutnowy) c) dovetail joint (Klecie) d) lap joint (Klecie) e) mortise and tenon (Nowa Kościelnica) f) lap joint (Nowa Kościelnica)

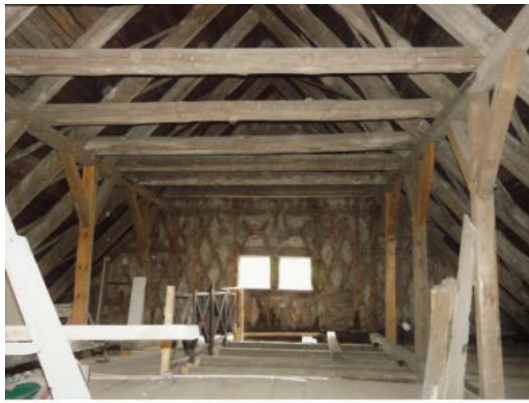
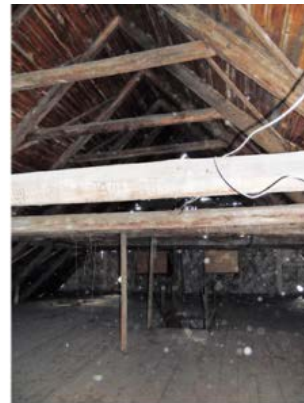
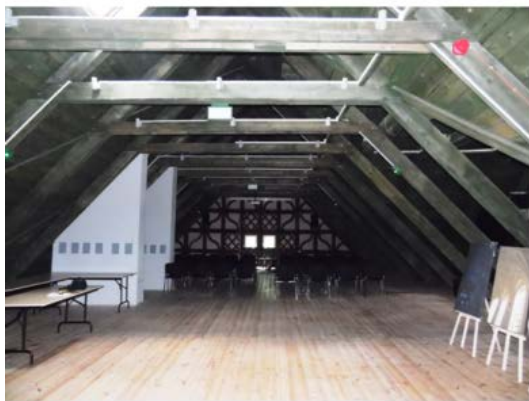
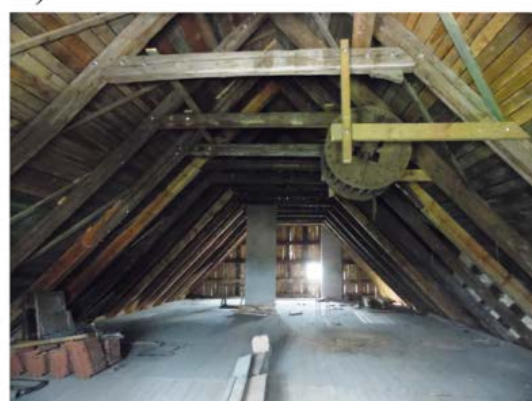
Figure 7. The timber roof truss – current state: a) Trutnowy b) Klecie c) Miłocin  
d) Nowa Kościelnica

It is worth noting the good technical condition of the roof structures in the houses analysed from the 17th and 18th centuries. This is caused by several factors. Homeowners make repairs systematically. In all buildings, the roof coverings are raintight, the attics have gravity ventilation (constant air circulation maintains the correct moisture of the wood), and there are no additional loads. This situation augurs well for the proper preservation of the historical structures in centuries to come. Such a way of maintenance is consistent with the principles of monument conservation and may be used in all wooden roof structures.
